AXIS TU8008 Media Converter

Specifications

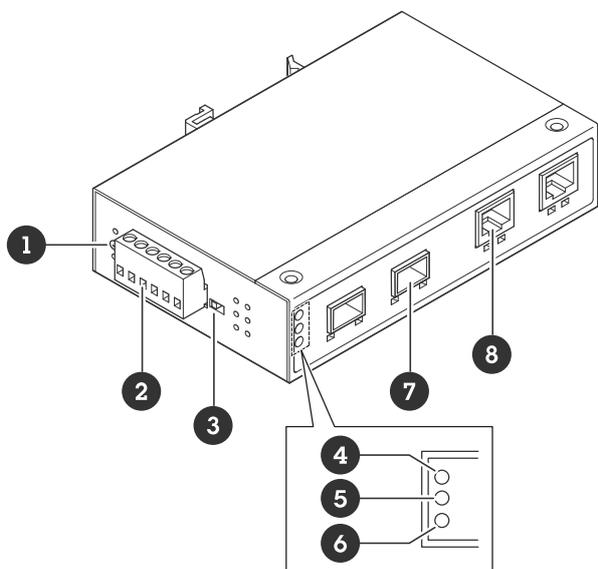
Product overview

- 1 Grounding screw
- 2 Terminal block connector
- 3 DIP switch
- 4 Alarm LED
- 5 Power LED
- 6 Power LED
- 7 SFP network ports x2
- 8 RJ45 network ports x2

LED	Color	Indication
PWR1	Green	Power 1 has power.
PWR2	Green	Power 2 has power.
ALARM	Red	One or more events are triggering the alarm.

Color	Indication
Amber (steady)	The link over the port is successfully established at 100Mbps.
Amber (blink)	The media converter is actively sending or receiving data over the port.
Green (steady)	The link over the port is successfully established at 1000Mbps.
Green (blink)	The media converter is actively sending or receiving data over the port.
Amber + green (steady)	The link through the port is successfully established at 2500Mbps.
Amber + green (blink)	The media converter is actively sending or receiving data over the port.

LED	Color	Indication
10/100 LNK/ACT	Amber (steady)	The link over the port is successfully established at 10Mbps or 100Mbps
	Amber (blink)	The media converter is actively sending or receiving data over the port
1000 LNK/ACT	Green (steady)	The link over the port is successfully established at 1000Mbps
	Green (blink)	The media converter is actively sending or receiving data over the port

DIP	Position	Function
Fiber Mode	ON	Fiber redundancy
	OFF (default)	Switch mode
